METALLURGICAL EXAMINATION OF A DAMAGED V-22 HYDRAULIC LINE

1 SEPTEMBER 1995

FINAL REPORT

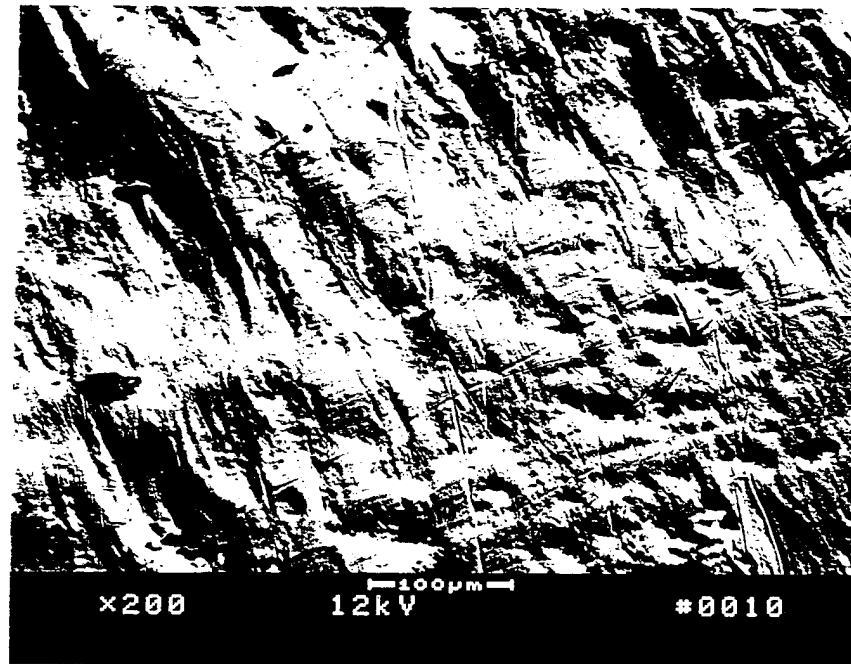
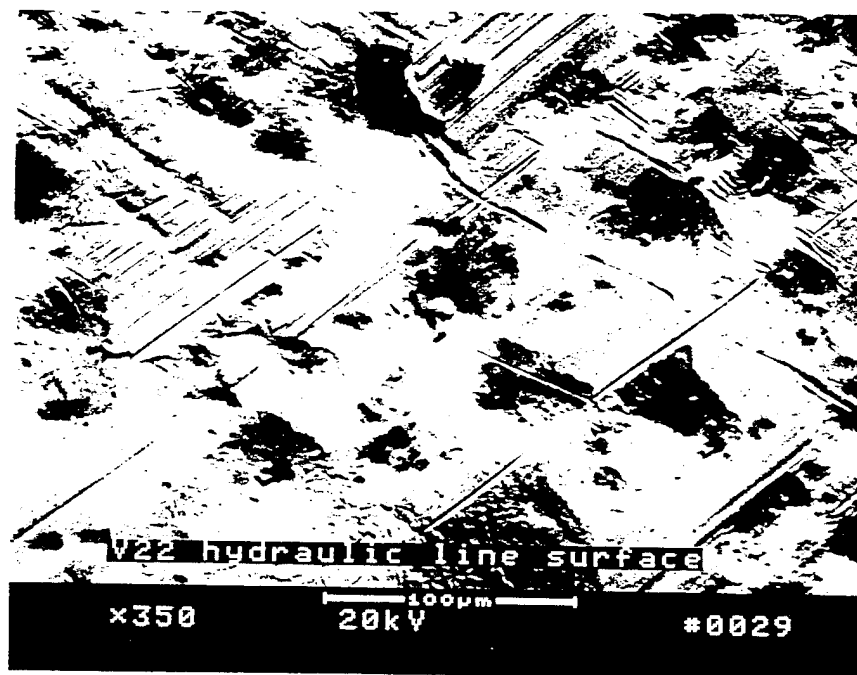
Figures 2 and 3 are SEM micrographs of the damaged surface and the corresponding cross-section of the pump suction tube (as-received). Pits and gouges were detected on the surface; no evidence of cracking and intergranular attack was found. However, there was some directionality observed with the orientation of some pits. These particular pits were aligned as if created by some mechanical means. The micrographs also reveal a fine grained, oriented alpha-beta microstructure, in which the alpha is observed as the lighter phase dispersed in the darker beta matrix.

The surface of the damaged tube was observed to be pitted with an indication of abrasion, **Figure 2**. There was a bimodal distribution of pit sizes. The larger pits were rounded with scratches running through them. The smaller pits were more clearly defined with sharp edges. Generally, the surface of the tube was free of oxides and other corrosion products (e.g. titanium hydrates). Upon close examination of the pitted areas, a second phase of particles was found. EDS results of these second phase products are displayed in **Figures 5 and 6**, indicating a presence of Al and O. However, only constituent elements of Ti-3Al-2.5V were detected in the cross-sectional area of the damaged tube, as shown in the spectrum of **Figure 7**.

The directionality of the pits seen on the surface of the damaged tube, as shown in **Figure 2**, tends to imply some type of abrasion due to mechanical means. In addition, after metallographical preparation of the transverse section of the damaged area, no alteration in microstructure was detected; despite the existence of minor surface damage - depressions, as seen in **Figure 4**. Therefore, no microstructural indication of corrosion was present; but there was evidence of good texture control of the tubing (**Figure 3**). In general, the surface topography of

the damaged hydraulic line tended to resemble those that are caused by classic cases of fretting, more particular to its early onset.

Figure 2: SEM micrographs of the damaged surface of the V-22 Hydraulic Line (as-received).

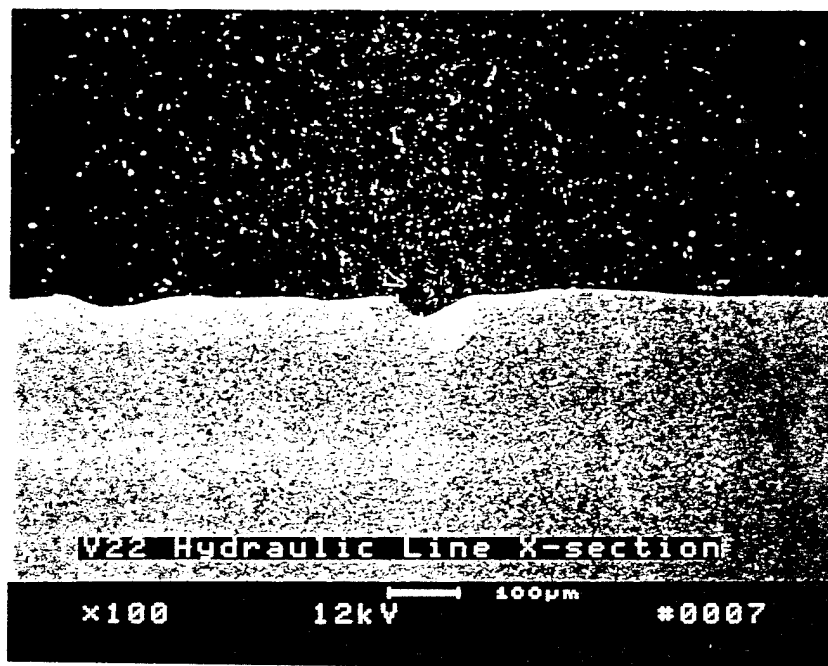
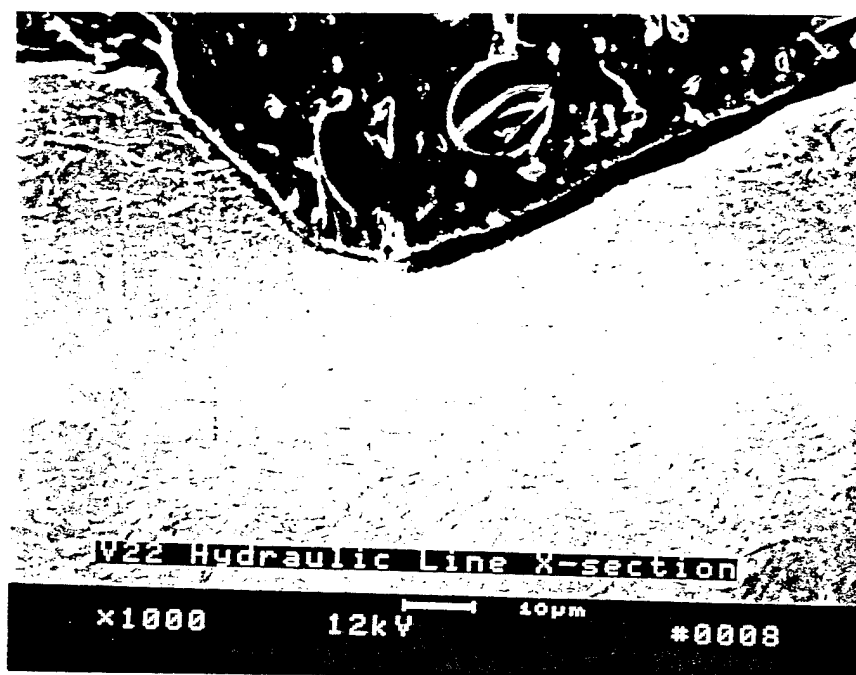
Figure 3: SEM micrographs of the damaged cross-section of the V-22 Hydraulic Line.
Samples were polished and etched in Kroel's reagent (3:1).

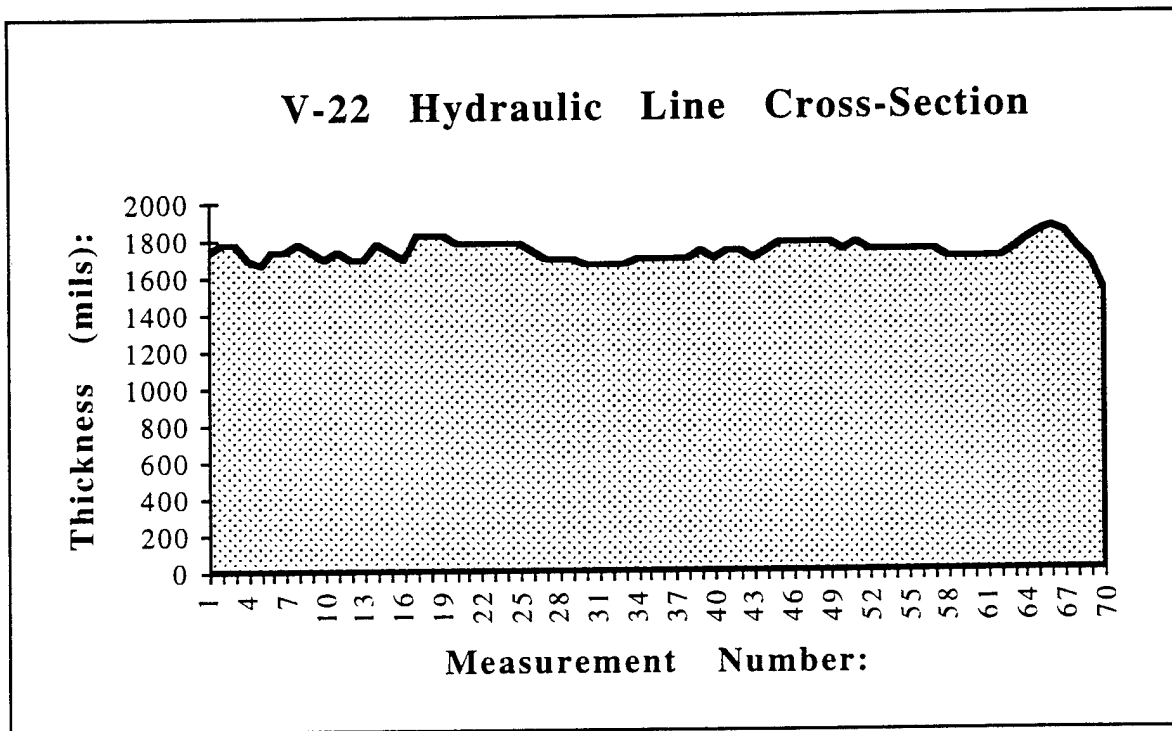
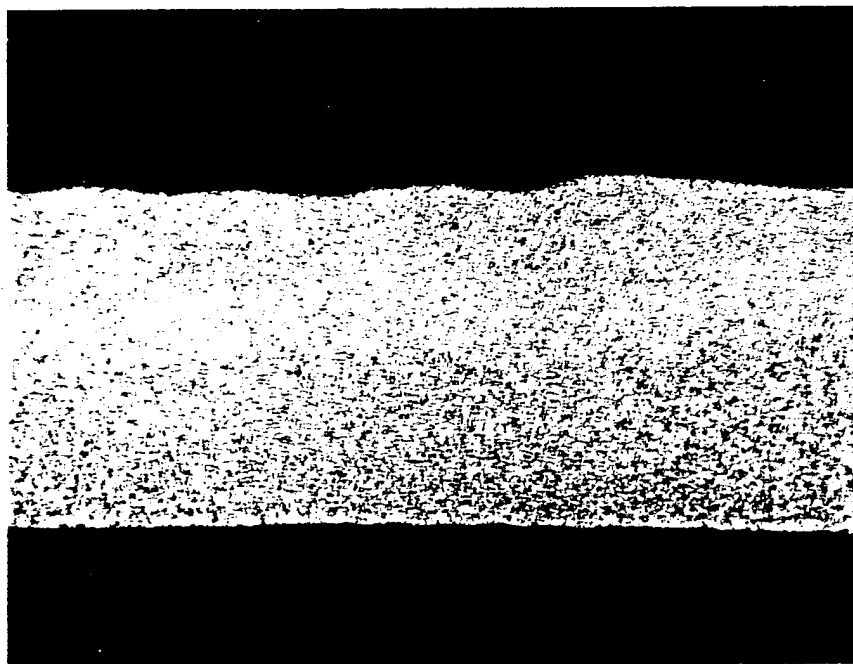
A profile of a representative cross-section of the damaged tube is portrayed in **Figure 4**. This was constructed from a compilation of linear measurements of the damaged tube's cross-section taken from optical micrographs (of which an example is also included in **Figure 4**). A maximum pit depth was measured to be approximately 30 mils (0.07 cm). The average thickness of the V-22 hydraulic line was determined to be 1750 mils (4.45 cm) with a standard deviation of 50 mils (0.13 cm).

Figure 4: A compiled cross-section of the damaged V-22 Hydraulic Line obtained with linear measurements taken from optical micrographs of the entire cross-section.
(An example of a photographed cross-sectional area is shown below.)

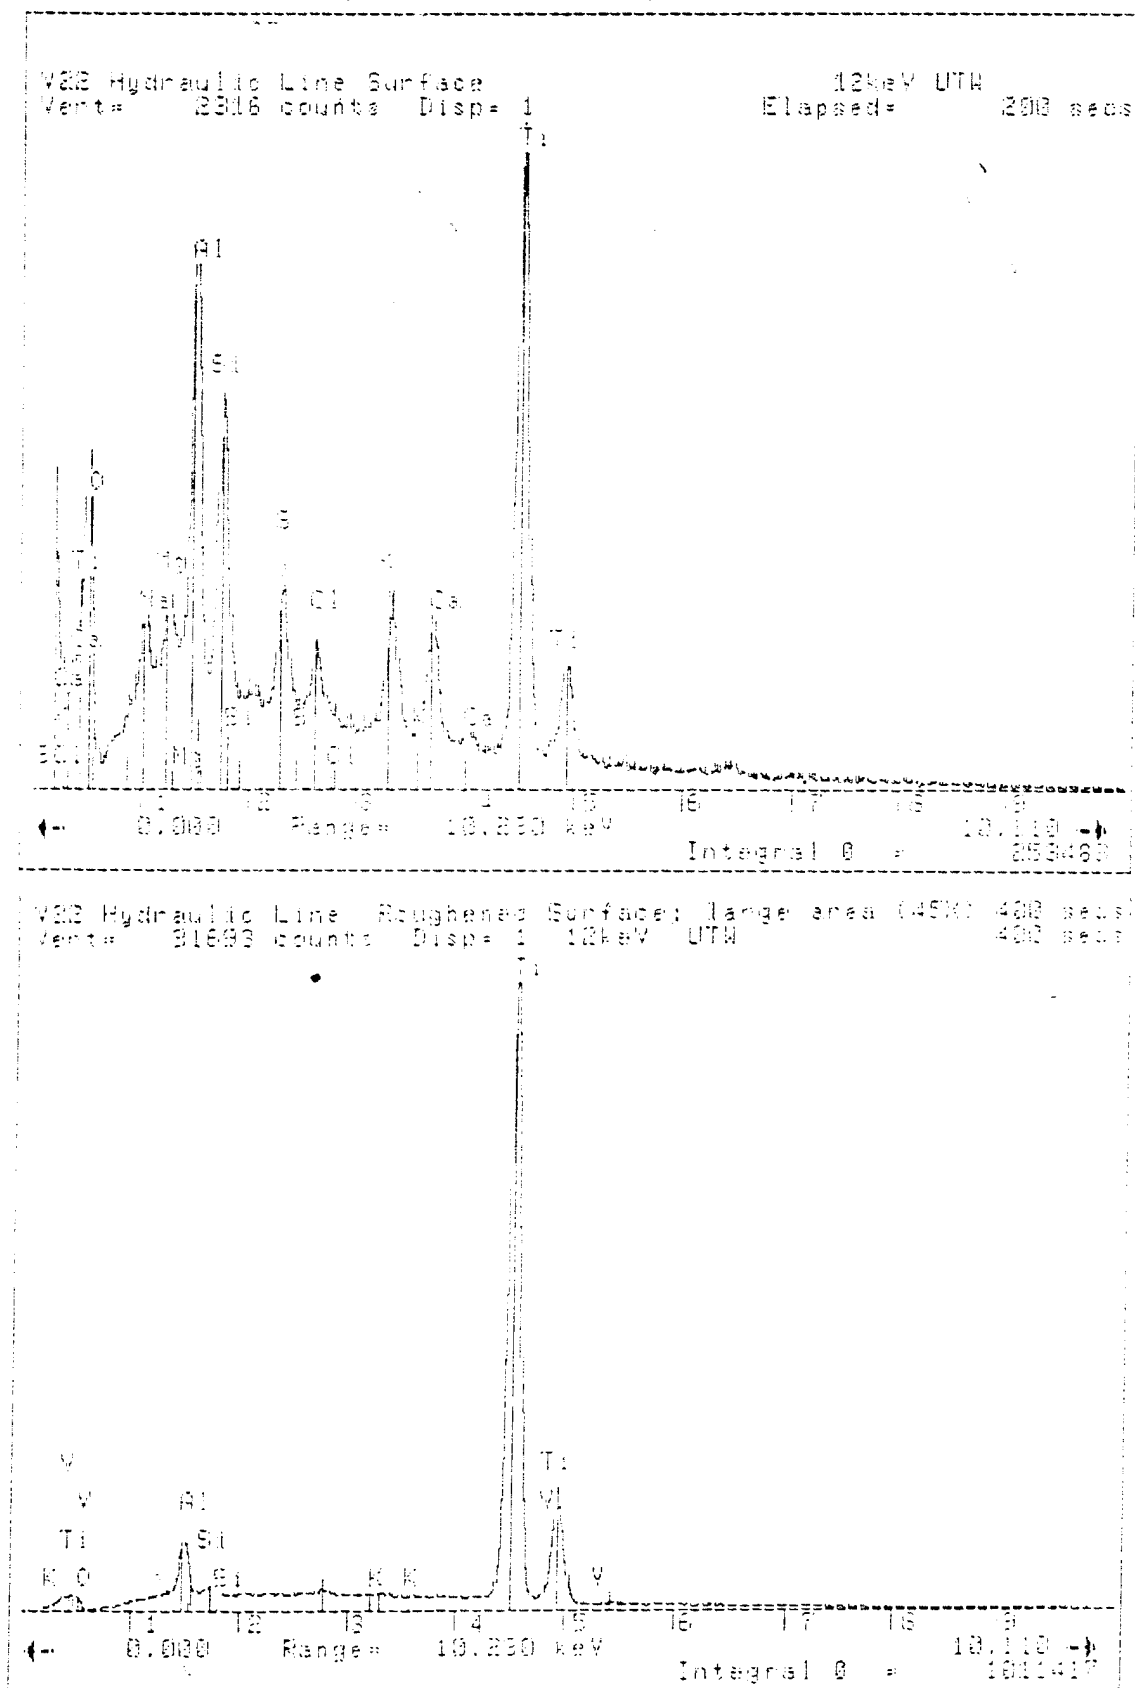
Figure 5: Elemental analyses (EDS) of the damaged surface of the V-22 Hydraulic Line.

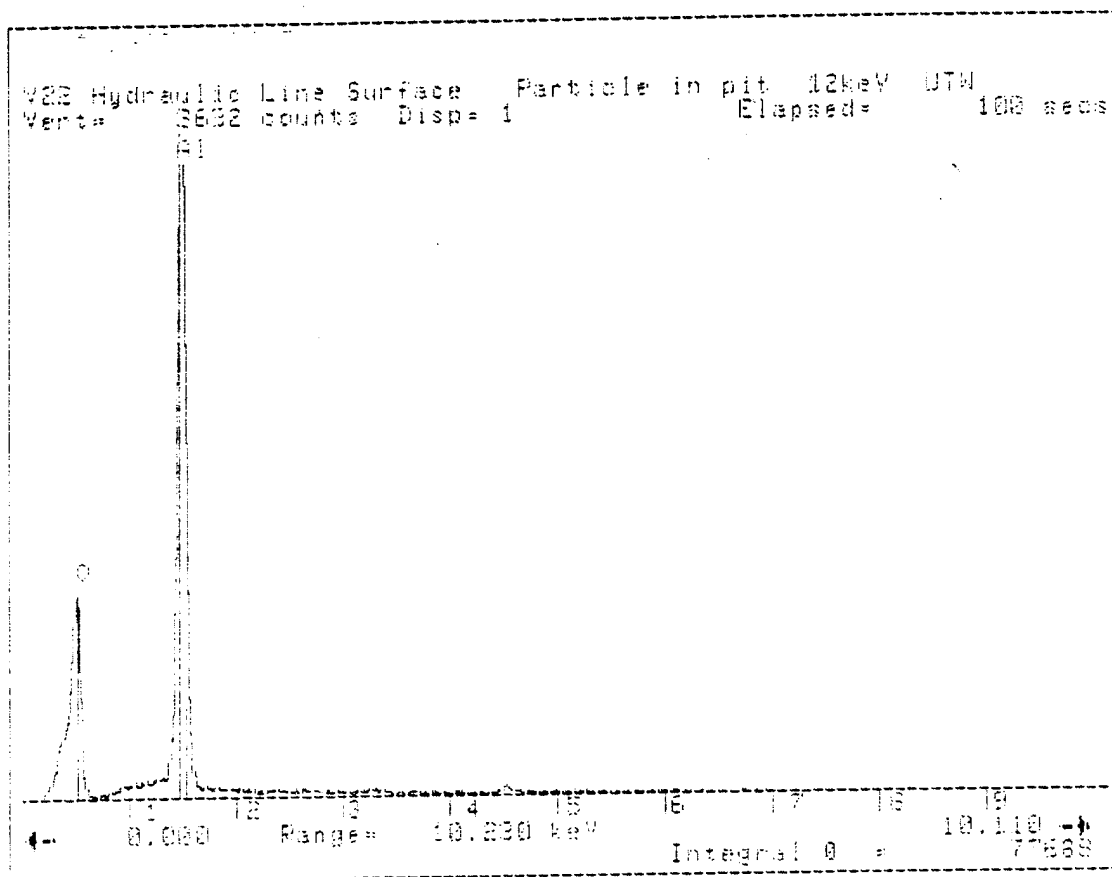
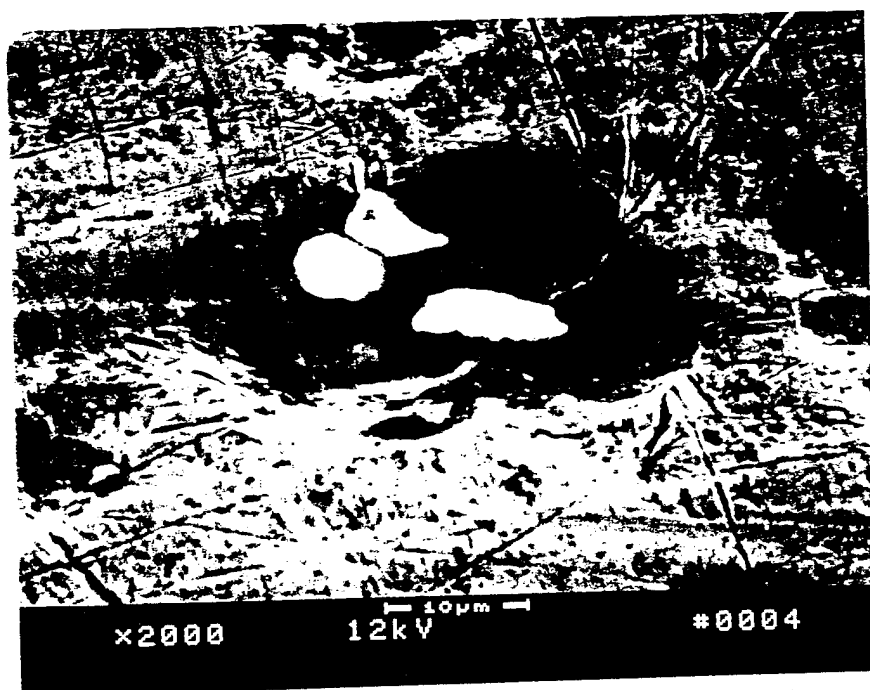
Elemental analyses (EDS) had shown a large quantity of foreign elements present in both the damaged area (surface) of the tube and its connecting rubber clamp, but not in its corresponding cross-section, **Figures 6-10**. Yet, there was no evidence of any corrosion by-products. However, identifying the foreign particulates as largely sand (SiO_2) and alumina (Al_2O_3), as seen from the resulting spectra of **Figures 6 and 8** respectively, had suggested that it was most likely the hostile environment that this piece of suction tube was subjected to that led to the contamination of the contact areas of its surface and of the rubber clamp; thereby created the damage observed. This was also verified from the two similar spectra obtained of the darkened areas on the pitted surface and on the rubber clamp, **Figures 9 and 10**.

Figure 6: Elemental analysis (EDS) of the foreign particulates discovered of the surface of the damaged V-22 Hydraulic Line.

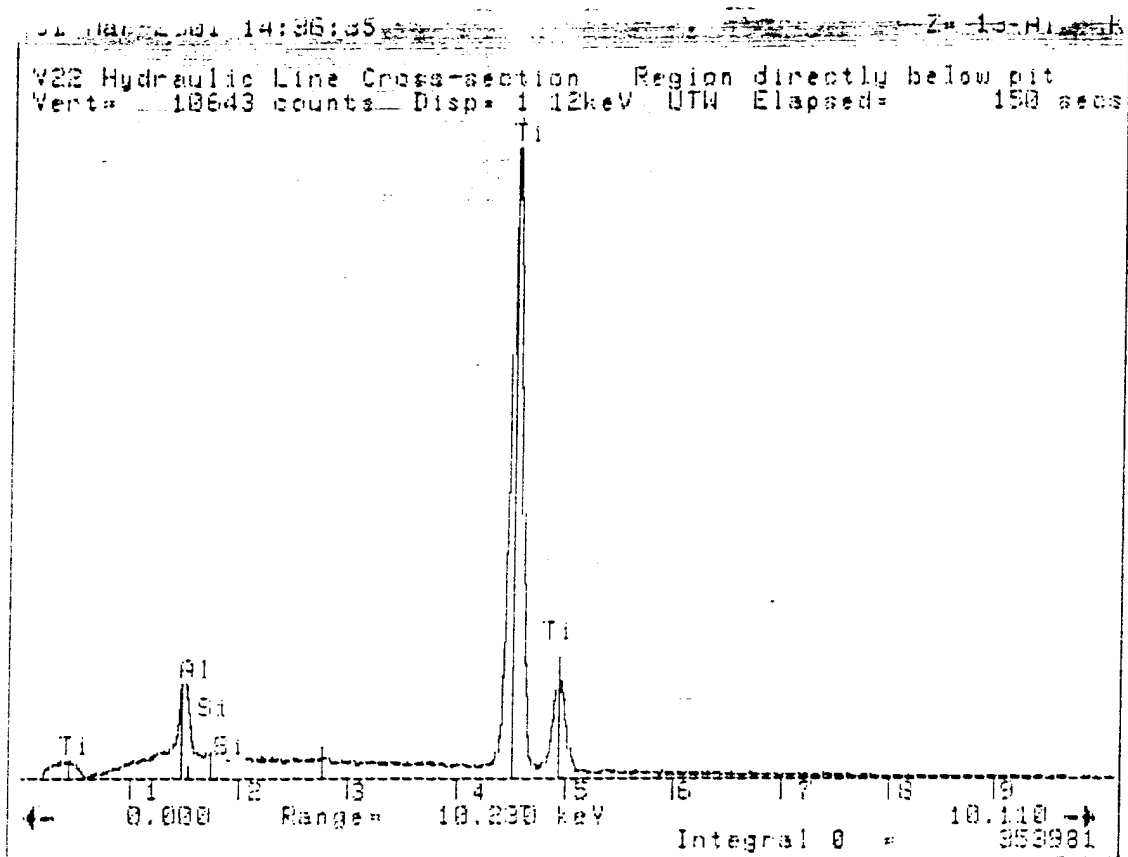
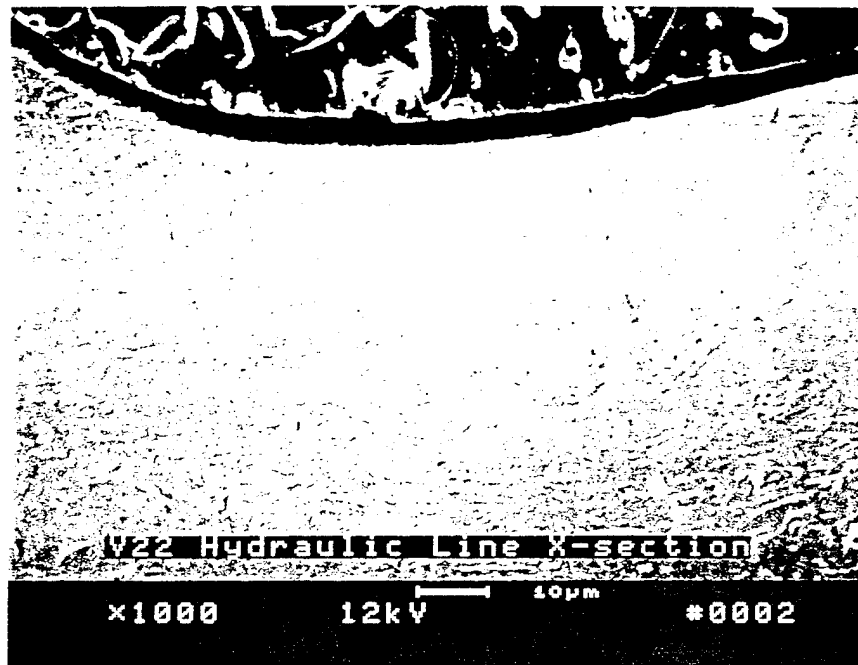
Figure 7: Elemental analysis (EDS), along with its corresponding SEM micrograph, of the damaged V-22 Hydraulic Line's cross-section. Sample had been polished and etched in Kroll's reagent (3:1).

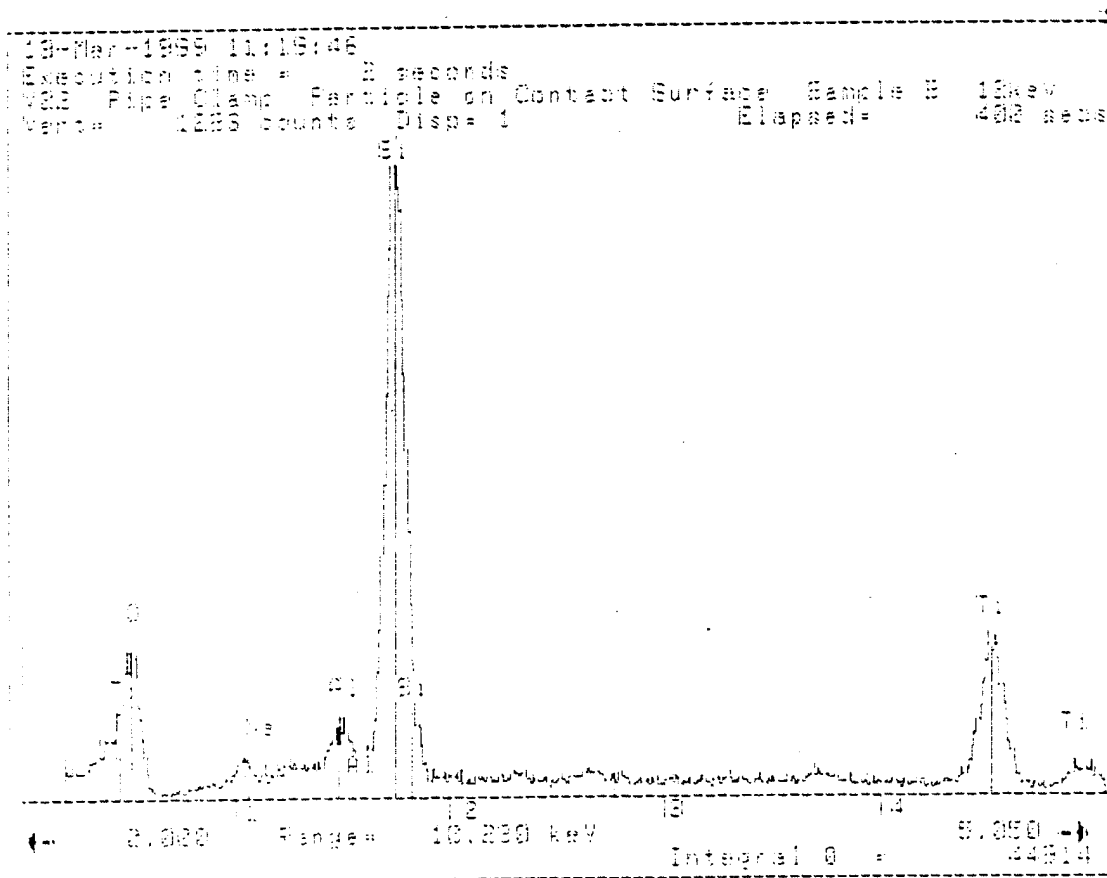
With regard to the corresponding contact area of the rubber clamp, large peaks of Si and O were identified by EDS (**Figure 8**). Furthermore, the black gritty area of the clamp, when compared to the nascent rubber, was discovered to contain large peaks of C, Na, O, and S with an additional presence of Ca and K (**Figure 9**). This result is similar to the EDS spectrum of the darkened pit areas of the tube (**Figure 10**).

Figure 8: Elemental analysis (EDS) of the rubber clamp's surface that was in contact with the damaged V-22 Hydraulic Line.

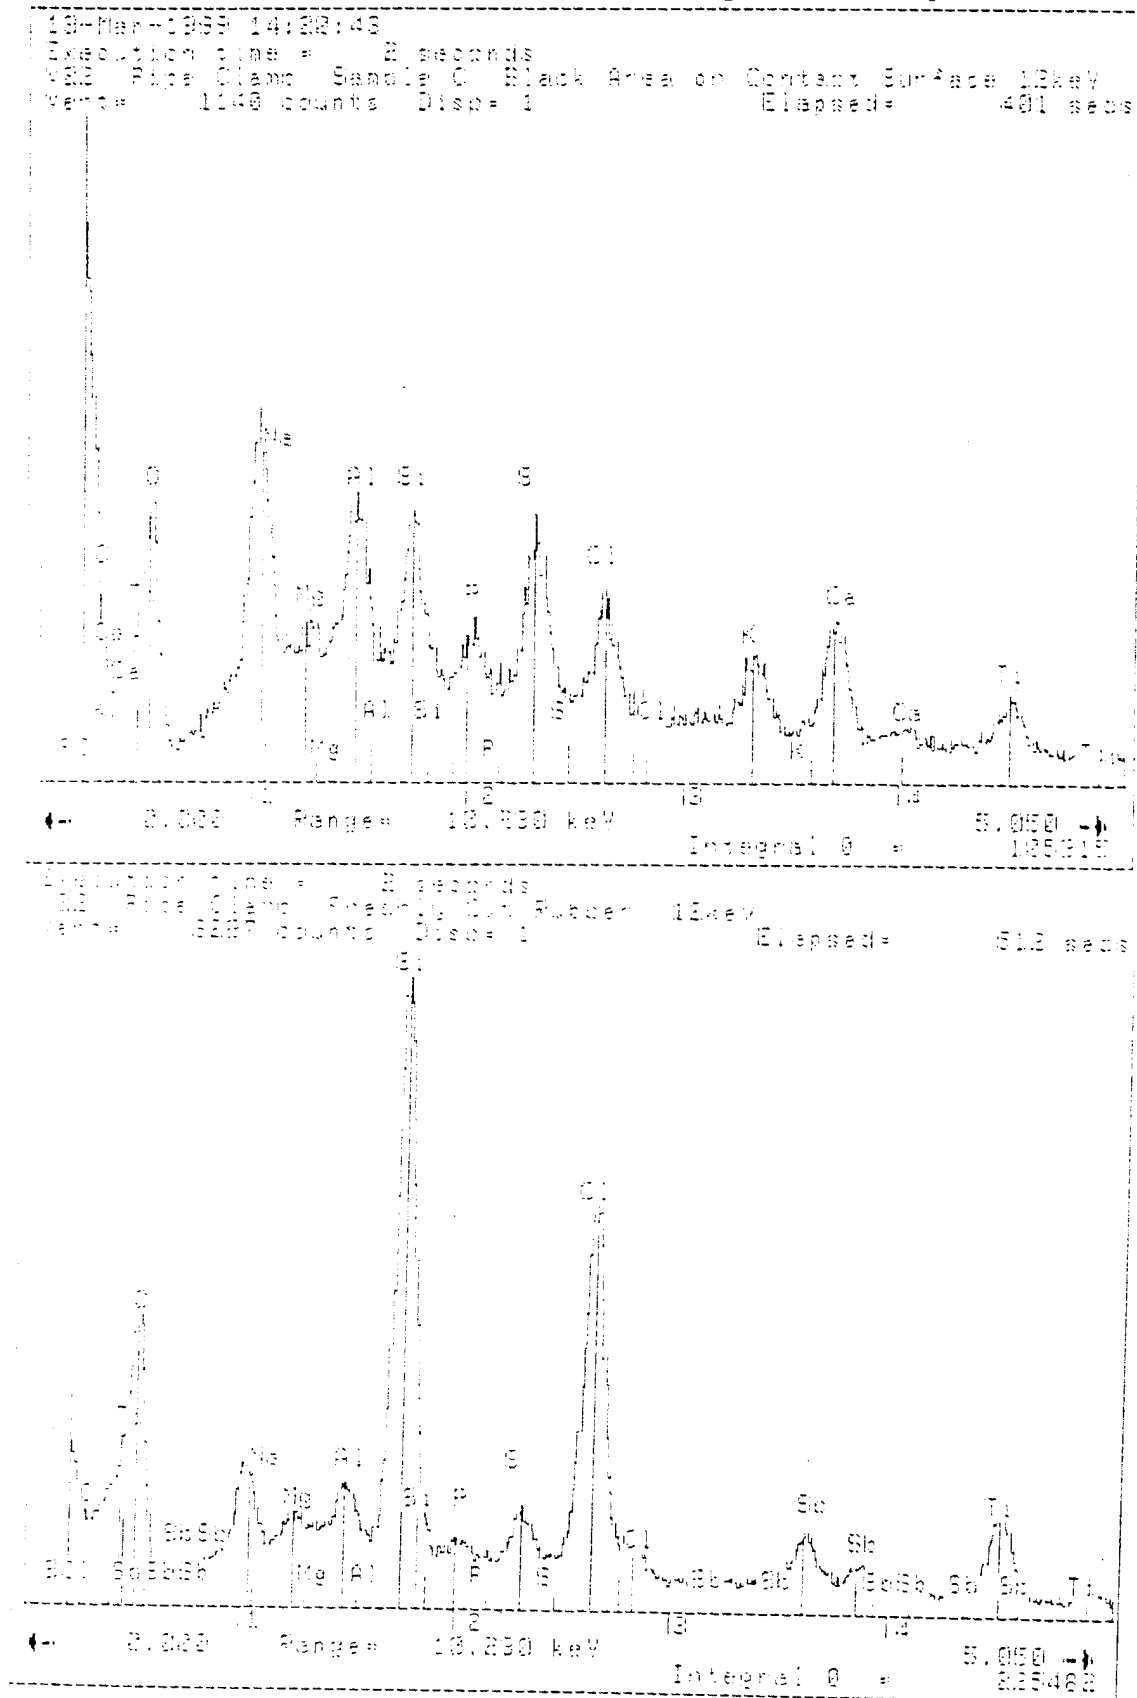
Figure 9: Elemental analyses (EDS) of the damaged V-22 Hydraulic Line's contacting rubber clamp and of a nascent rubber clamp (of same mil-spec.).

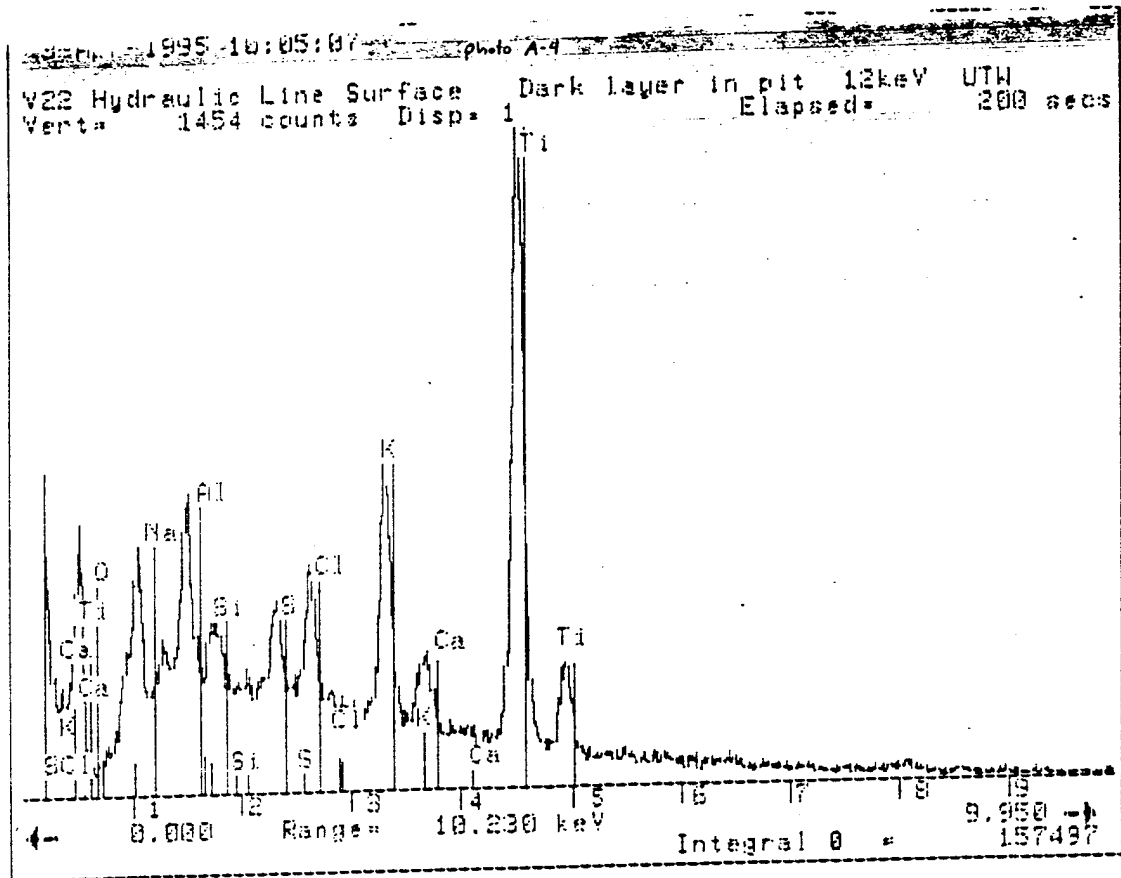
Figure 10: Elemental analysis (EDS), along with its corresponding SEM micrograph, of the darkened areas on the surface of the damaged V-22 Hydraulic Line.

The evidence suggests that the damage done to the V-22 hydraulic line was from the cyclical and vibratory motion of very small foreign particulates, obtained from the surroundings, that became embedded in and between the surfaces of the tube and of the contacting rubber clamp. Elimination of these contaminants would smoothen the contact surfaces and prevent any premature damage of this pump suction tube from occurring and/or recurring.
